**Docket No. 217 – Development and Management Plan Inspection**

Northeast Utilities Service Company Certificate of Environmental Compatibility and Public Need for the construction of a 345-kV electric transmission line and reconstruction of an existing 115-kV electric transmission line between Connecticut Light and Power Company's Plumtree Substation in Bethel, through the towns of Redding, Weston, and Wilton, and to the Norwalk Substation in Norwalk, Connecticut.

**Date:** August 16, 2006

**Location:** 345kV Underground Route

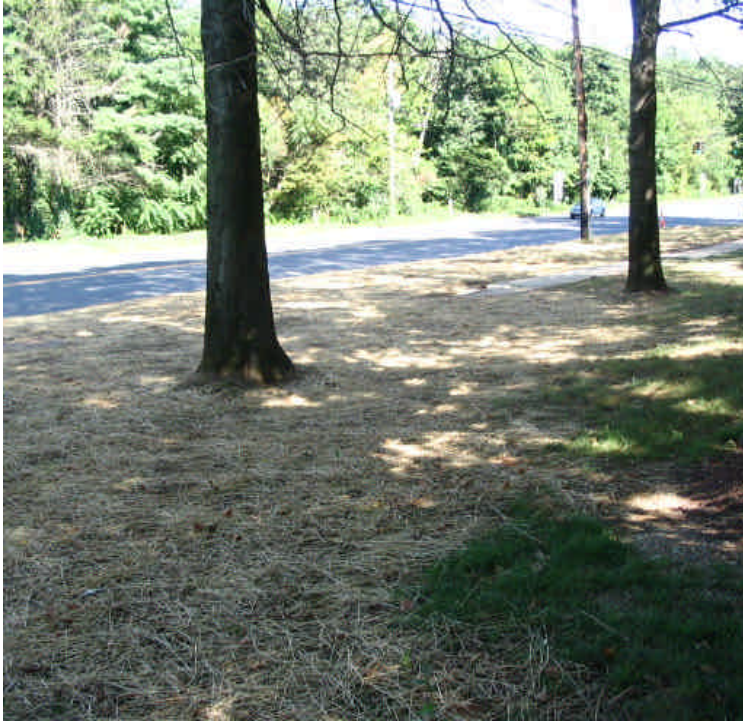
345kV: Photo on the left shows where the vault work area at the Wilton Corporate Park was restored with seed and mulch. Continue to repair sidewalk if necessary. Photo on the right shows where some grading near Old Danbury Rd caused some of the stone to crush the silt fence. 8/16/06

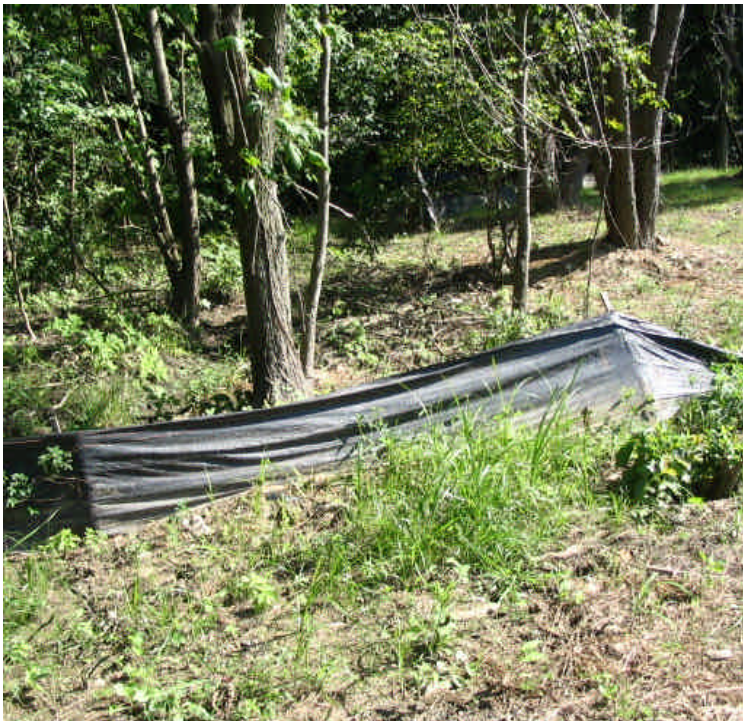
(School Rd) Photo on the left shows a view of the silt fence at the top of the channel on the east side of the old HDD. It was repaired as recommended. Photo on the right shows a view along the channel here. Some vegetation continues to return. 8/16/06

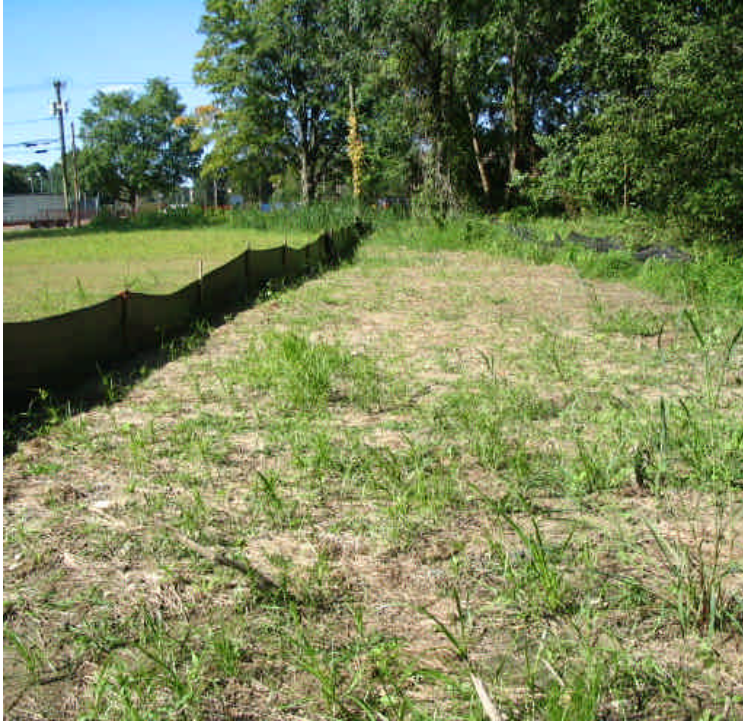
Photo on the left shows a view of the eastern side of the HDD where vegetation is finally beginning to return after the restoration efforts. Photo on the right shows the apparent spill still remaining in the gravel at the Rt 107/7 intersection storage area 8/16/06

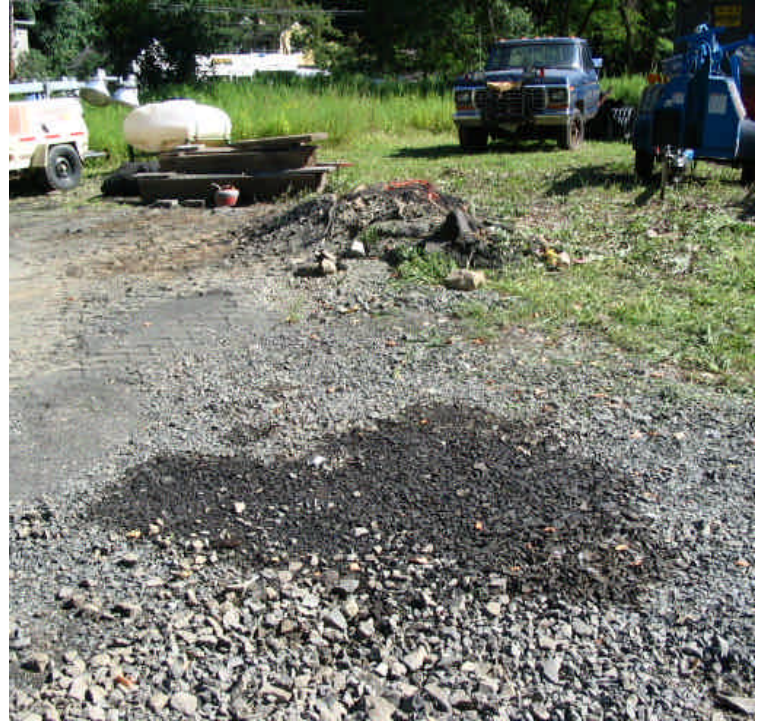
Areas of Inspection	Observation	Recommended Action	Corrective Action
Spills and Material Storage	<ul style="list-style-type: none"> <li>- In general, make sure that glues, asphalt components and other materials are stored well overnight and not left out along the roadway. 8/16/06</li> <li>- A spill remains in the gravel at the Rt 107/7 storage area. Pick up and remove affected stone/soil 8/3-8/16/06</li> <li>- A concrete washout was noted to the sidewalk and roadway on 8/9/06 but was not observed this inspection</li> </ul>	<ul style="list-style-type: none"> <li>- The contractors should remain vigilant about securing and handling fuel containers.</li> <li>- Continue to keep all vehicles maintained well (i.e. no apparent fluid leaks) if they will be used or stored on site.</li> <li>- Check equipment status on a regular basis and keep spill kits on hand.</li> <li>- Report spills immediately, even if they are being controlled.</li> <li>-Continue to remind drivers to wash out to contained areas. 8/16/06</li> </ul>	<ul style="list-style-type: none"> <li>-N/A</li> <li>- Needs attention</li> <li>- N/A</li> </ul>

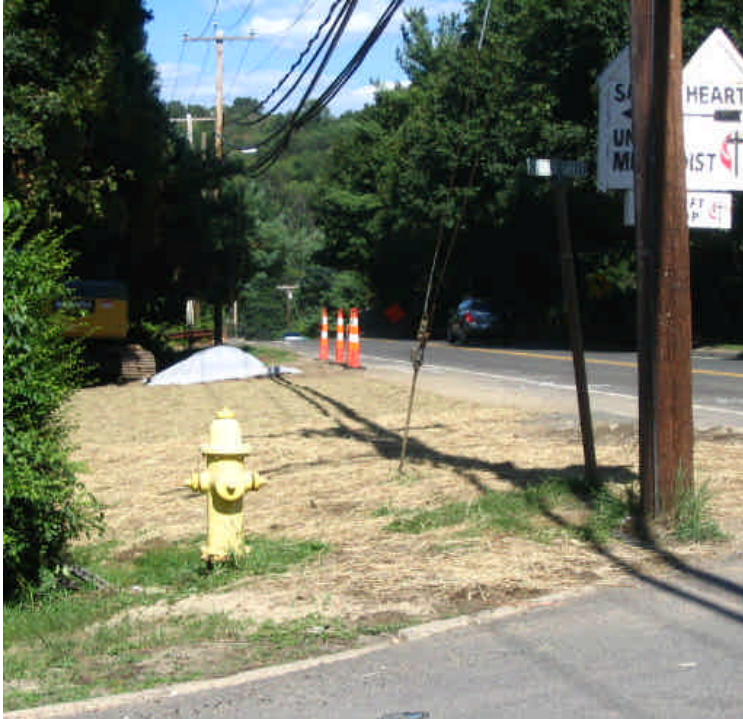
(Georgetown): Photo on the left shows where the work at Church St and the exit point of the HDD is complete. The area was restored with seed and mulch. Photo on the right shows a view of the completed HDD site in the Gilbert & Bennett lot. Seed and mulch are still needed here. 8/16/06

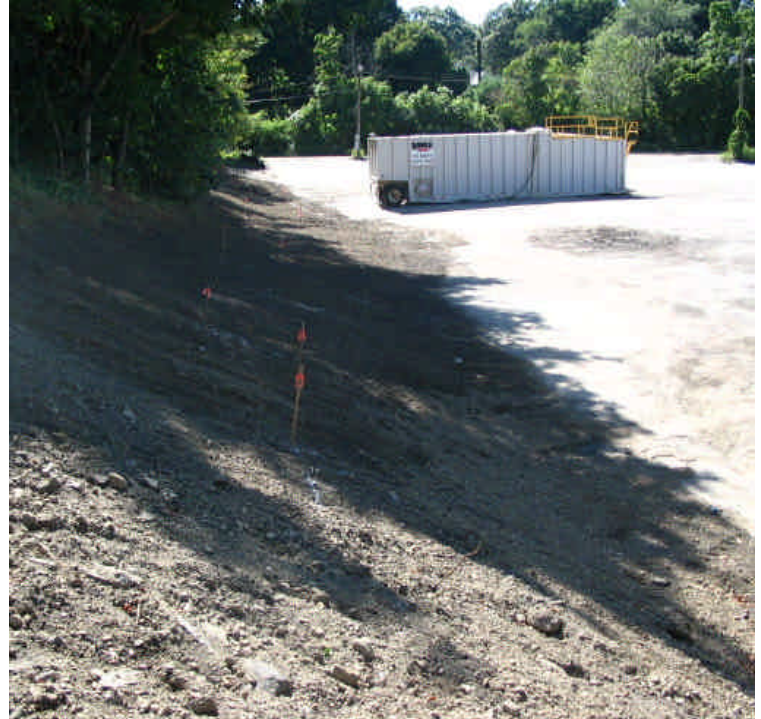
Areas of Inspection	Observation	Recommended Action	Corrective Action
Erosion and Sediment (E&S) Controls continued	<ul style="list-style-type: none"> <li>- At the Georgetown HDD site (Gilbert &amp; Bennett lot), the slope where the trenching had occurred was graded but did not appear to have been seeded yet. 8/9-8/16/06</li> <li>- At the HDD exit at Church St the work was complete and silt fence removed. 8/16/06</li> </ul>	<ul style="list-style-type: none"> <li>- Seeding and mulching needs to occur. Determine whether the slope will require mats for stabilization as this area may erode. 8/3-8/16/06</li> <li>- The work is complete in the area. 8/16/06</li> </ul>	<ul style="list-style-type: none"> <li>-Needs restoration.</li> <li>- N/A</li> </ul>
<b>Umpawaug Rd. And Diamond Hill Rd.</b>	<ul style="list-style-type: none"> <li>-Most roadside areas have been restored. A few areas may need additional attention. 8/9-8/16/06</li> </ul>	<ul style="list-style-type: none"> <li>- Continue to restore any remaining areas and install controls if necessary. 8/9-8/16/06</li> </ul>	<ul style="list-style-type: none"> <li>- N/A at this time</li> </ul>
